The Trafalgar Marine Phoenix project was launched on Friday 24/02/2006 when Paul and myself viewed a burnt out canal boat at Marple BWB yard.

The 42ft boat was in quite a state after teenage vandals had set it (and another two boats) alight early one winter morning (sods).

The main problem with the boat was the front section of roof which had been badly rippled during the fire.

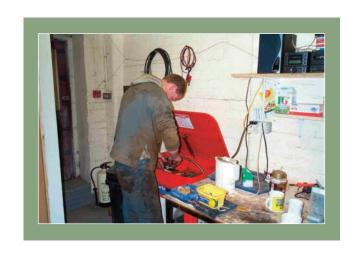
The oil filter is also taken out and cleaned in motorbike man's parts washer.

The replaceable body of the filter is thrown out, only the top of the filter is cleaned out.

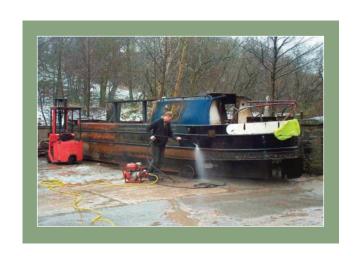
Since Paul is already wet he decides to pressure wash the bottom of the hull on both sides.

It is advisable to pressure wash your boat before painting to remove any rust, barnacles etc., as this gives a better surface for the paint.

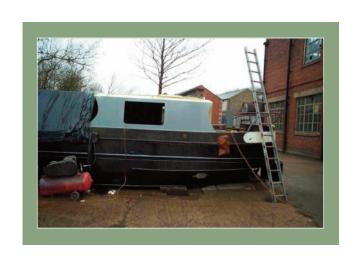
The outside of the back cabin is then spray painted with grey oxide primer and left to dry.

Another coat is applied when the first has hardend.

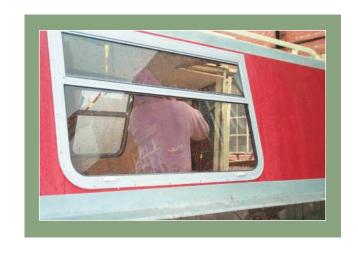
The rear bulkhead is attached. We haven't welded in a steel bulkhead so the wood will need a couple of coats of a good preserver.
